► Reinforcement for Adhered Veneer Stone - Problems and Solutions

Bulletin Revised November 2024

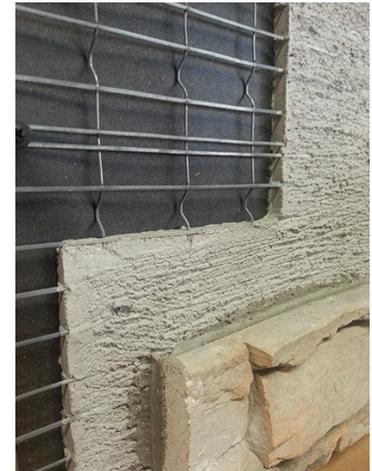
Manufacturers then require a 1/2" scratch coat to be applied and cured for a 48-hour period. The stone is then to be embedded in 1/2" of mortar with mortar being squeezed out between the joints. The key objective is to obtain close to 1" total thickness of plaster. This plaster is critical in providing the effective water barrier. The building paper in behind, can only manage incidental moisture that may get past the plaster.
